CASE STUDY

- 75% WOUND REDUCTION IN 6 WEEKS
- 3 YEAR OLD WOUND
- 6 ACTIGRAFT APPLICATIONS

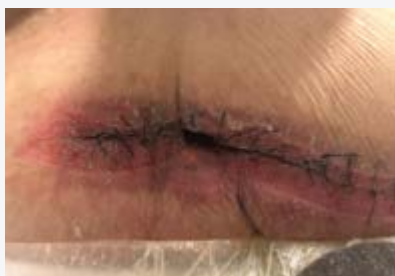
Week 1

ACTIGRAFT TREATMENT PROGRESSION:

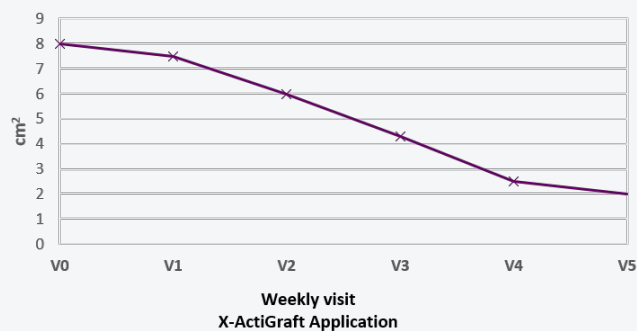
Wound Area cm²

V=Weekly Application
